Manhole Inspection Summary

Manhole # S170__027MH

Insp Date: **2/26/09 1:26 PM**

Location Address: **2442 CHRISTIAN ST**

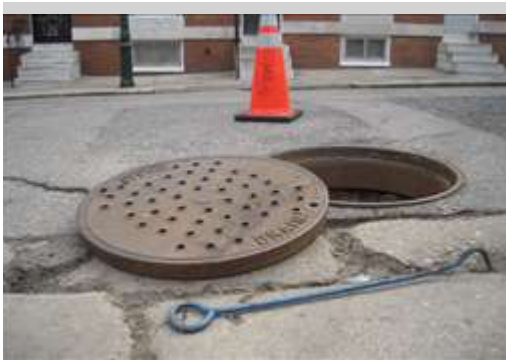
Miscellaneous

COVER IS VENTED STORM

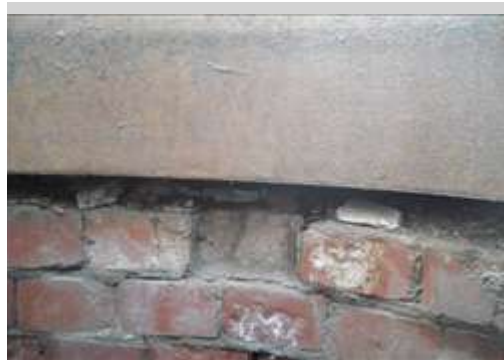
Defect 5

Condition: ☐ Sound ☐ Cracked ☐ Root Intrusion ☒ **Loose Brick** ☒ **Deteriorated**

Chimney loose bricks, deteriorated 3" GAP BELOW FRAME

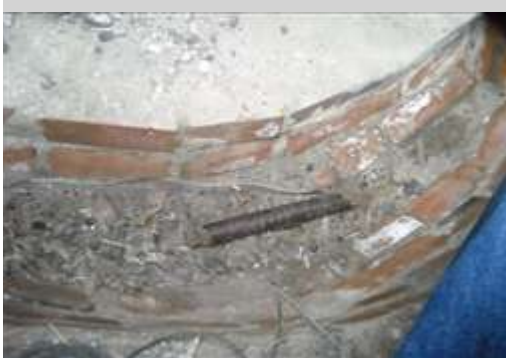
Defect 4

Condition: ☐ Sound ☐ Cracked ☐ Root Intrusion ☐ Deteriorated ☐ Leaks ☒ **Debris**

DEBRIS IN CHANEL

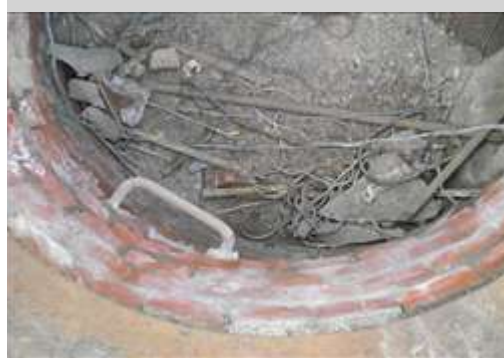
Defect 3

Condition: ☐ Sound ☐ Cracked ☐ Root Intrusion ☒ **Deteriorated** ☐ Leaks ☒ **Debris**

DEBRIS ON BENCH

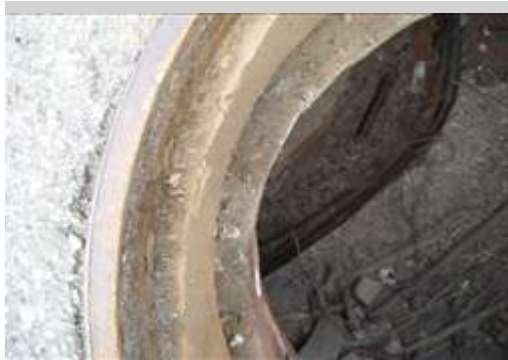
Defect 2

Frame Offset: **3** (in.) Condition: ☒ Sound ☐ Cracked ☐ Leaks

3" FRAME OFFSET

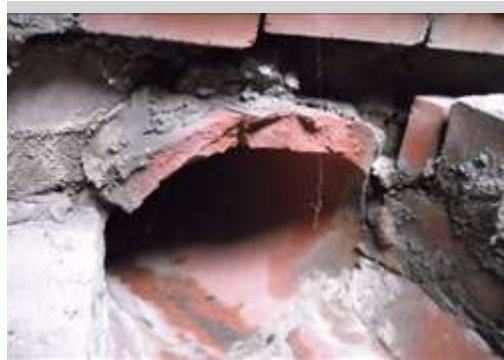
Defect

Condition: ☐ Sound ☐ Cracked ☐ Root Intrusion ☒ **Loose Brick** ☒ **Deteriorated**

Barrel loose bricks & deteriorated; bench deteriorated

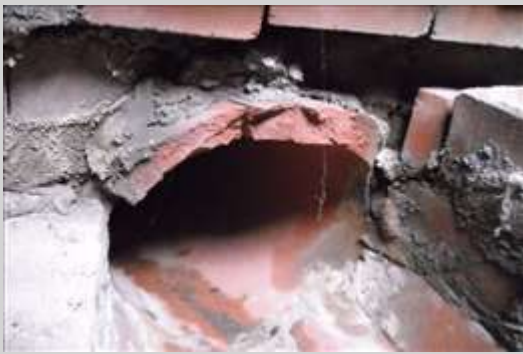
12 O'Clock Outflow

NOTE CRACK IN CENTER, AND CRACKED
BROKEN SIDES WITH POOR SEAL

Infiltration: **None** Pipe Seal Cond: **Broken**

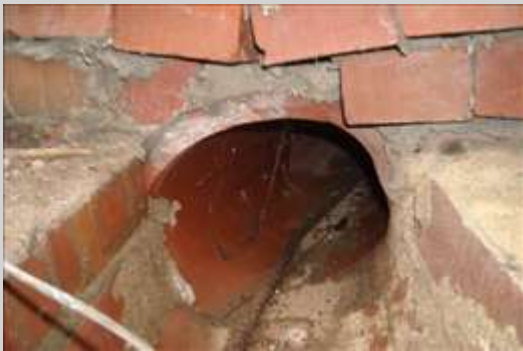
8 O'Clock Inflow

NOTE ROD IN PIPE

Deposits: ☐ None ☐ Mud ☐ Sludge ☒ **Debris** ☐ Grease

Silt Depth: **1** (in.) Deposits Extent: **Light**
